DEPARTMENT OF TRANSPORTATION

Quality Assurance and Source Inspection

Contract #: 04-0120F4Cty: SF/ALA Rte: 80 PM: 13.2/13.9File #: 69.28**WELDING INSPECTION REPORT****Resident Engineer:** Pursell, Gary**Address:** 333 Burma Road**City:** Oakland, CA 94607**Report No:** WIR-007528**Date Inspected:** 18-Jun-2009**Project Name:** SAS Superstructure**OSM Arrival Time:** 700**Prime Contractor:** American Bridge/Fluor Enterprises, a JV**OSM Departure Time:** 1800**Contractor:** Zhenhua Port Machinery Company, Ltd (ZPMC), Changxing Island **Location:** Shanghai, China**CWI Name:** Xu Le Feng, Liu Yang**CWI Present:** Yes No**Inspected CWI report:** Yes No N/A**Rod Oven in Use:** Yes No N/A**Electrode to specification:** Yes No N/A**Weld Procedures Followed:** Yes No N/A**Qualified Welders:** Yes No N/A**Verified Joint Fit-up:** Yes No N/A**Approved Drawings:** Yes No N/A**Approved WPS:** Yes No N/A**Delayed / Cancelled:** Yes No N/A**Bridge No:** 34-0006**Component:** TOWER**Summary of Items Observed:**

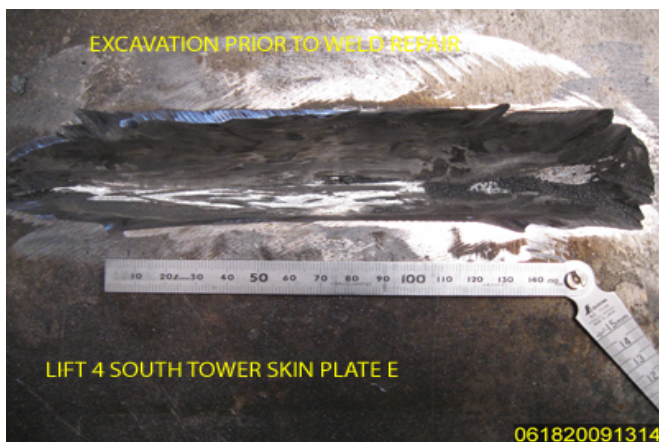
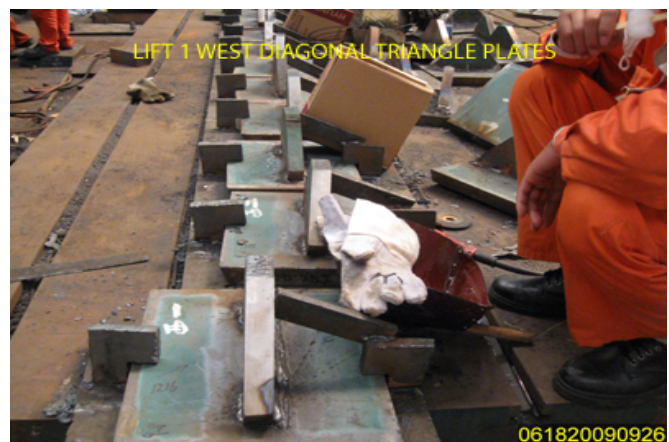
The QA Inspector randomly observed ZPMC welder Zheng Ming Ye ID 066155, utilizing the Flux Cored Arc Welding (FCAW) Process in the 2F (Horizontal Fillet) Position with ZPMC WPS WPS-B-T-2132 to weld the triangle plates to the diagonal plates for Lift 1 West Tower Shaft at Weld Joint (WJ) WSD1-TL6E/D-149. The QA Inspector randomly observed ZPMC QC monitoring weld parameters. Weld parameters appeared to comply with contract requirements. The attached photographs provide additional detail.

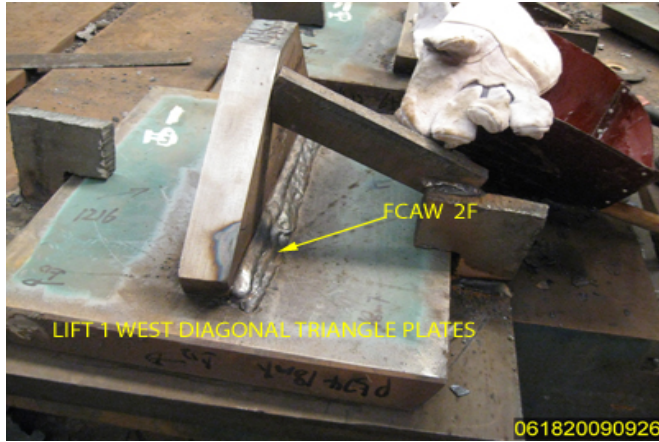
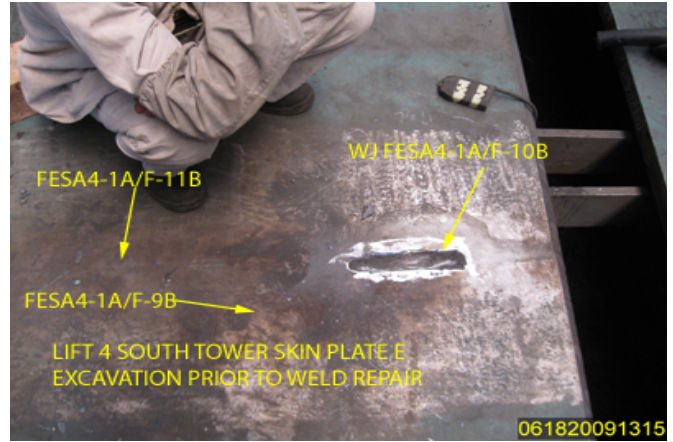
The QA Inspector randomly observed 1 ZPMC helper utilizing an angle grinder to clean up slag in an area in WJ SSD1-FESA4-1A/F-10B on Lift 4 South Skin Plate E; which was previously excavated with Carbon Air Arc Gouging. The attached photographs provide additional detail.
